DEPARTMENT OF TRANSPORTATION

Quality Assurance and Source Inspection

Contract #: 04-0120F4Cty: SF/ALA Rte: 80 PM: 13.2/13.9File #: 1.28**WELDING INSPECTION REPORT****Resident Engineer:**Siegenthaler, Peter**Address:** 333 Burma Road**City:** Oakland, CA 94607**Report No:** WIR-017218**Date Inspected:** 30-Sep-2010**Project Name:** SAS Superstructure**OSM Arrival Time:** 700**Prime Contractor:** American Bridge/Fluor Enterprises, a JV**OSM Departure Time:** 1100**Contractor:** American Bridge/Fluor Enterprises, a JV**Location:** Job Site**CWI Name:** Tom Pasqualone**CWI Present:** Yes No**Inspected CWI report:** Yes No N/A**Rod Oven in Use:** Yes No N/A**Electrode to specification:** Yes No N/A**Weld Procedures Followed:** Yes No N/A**Qualified Welders:** Yes No N/A**Verified Joint Fit-up:** Yes No N/A**Approved Drawings:** Yes No N/A**Approved WPS:** Yes No N/A**Delayed / Cancelled:** Yes No N/A**Bridge No:** 34-0006**Component:** OBG Section**Summary of Items Observed:**

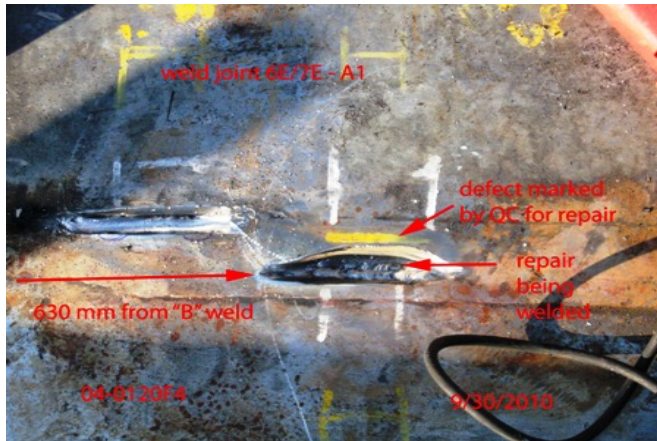
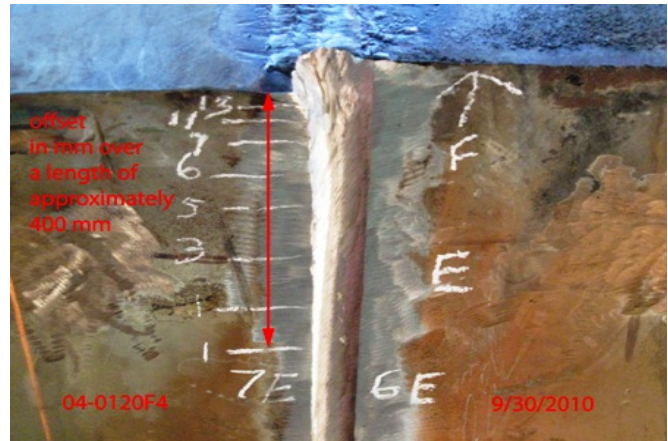
At weld joints E6/E7 – E1 and E2, outside the OBG section this QA Inspector observed the backing strap had been removed and the weld back gouged. As previously reported there was plainer misalignment for approximately 400 mm with the maximum being 13 mm adjacent to weld “F” at this location. See photos below for details. QC personnel have not performed Magnetic Particle Testing (MT) on the back gouged section of the weld as of this date.
